# Tiva™ C Series TM4C129x Microcontrollers Silicon Revisions 1, 2, and 3

## Silicon Errata

Literature Number: SPMZ850D  
October 2013–Revised March 2015

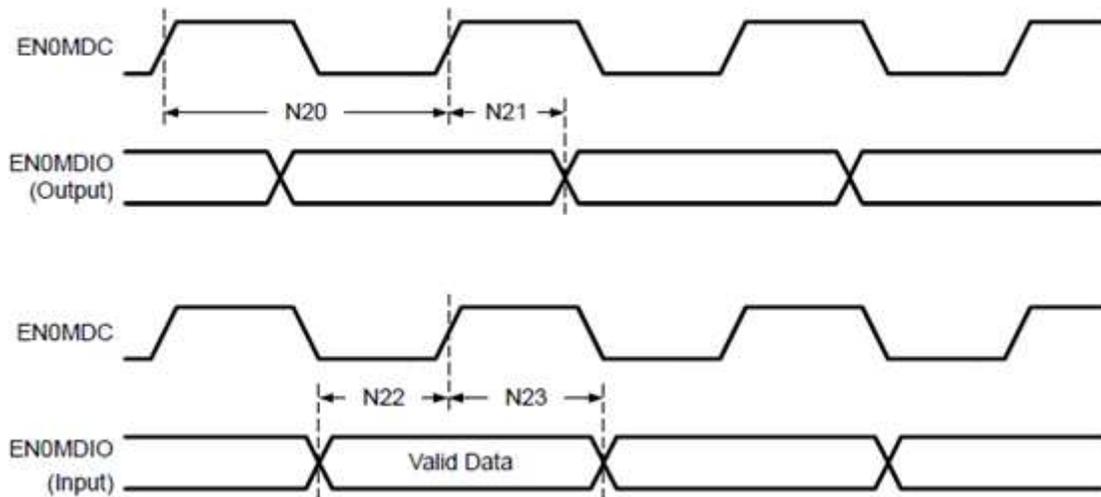
**ETH#05** *SMI Electrical Section Update (2)*
**Revision(s) Affected:** 1, 2, and 3.

**Description:** The following timing diagram in the Electrical Characteristics for Ethernet Controller AC Characteristics for MII Serial Management is the corrected diagram.

**Workaround(s):** None.

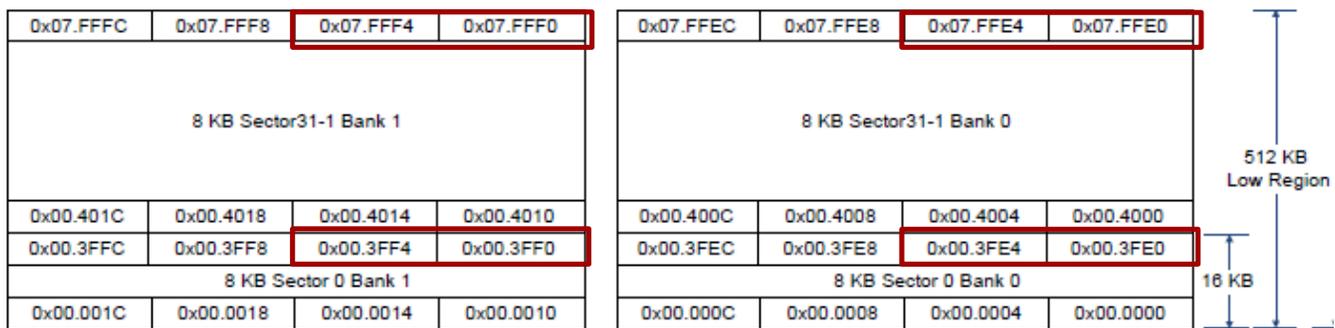
**MEM#15**                      ***Specific Flash Locations in any Sector do not get Erased***
**Revision(s) Affected:**    1, 2, and 3.

**Description:**                If only one or both of the first two words of the last line of a sector in a bank are programmed, an Erase of entire Sector, Mass Erase of device, or toggle mass erase does not erase the flash back to all 1's. The diagram below shows the affected words in Sector 0 and Sector 31 of the lower 512KB of Flash.

**Workaround(s):**                Program any other word in the Sector-Bank to allow Sector Erase to work.

**NOTE:** Toggle Mass Erase or Mass Erase will still not work.

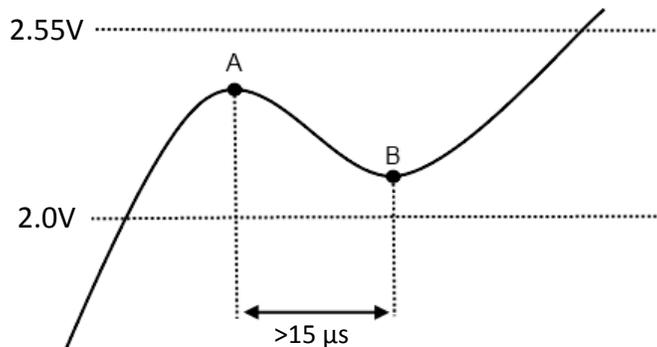
**Figure 3. VDDA Waveform to Avoid Between  $V_{POR}$  min and  $V_{POR}$  max**

**Description:** In very rare cases, a non-monotonic voltage rise of VDDA between the minimum and maximum Power-On Reset Threshold ( $V_{POR}$ ) voltage range, 2.0 V and 2.55 V, can cause the on-chip LDO to not start up. Because the LDO controls the core voltage (VDDC), the device cannot start up correctly in this situation. If the LDO fails to start, power cycle the device until a successful power up occurs. A software or hardware reset cannot restart the LDO.

**Workaround(s):** A monotonic voltage rise of VDDA prevents this issue from occurring; however, a perfect monotonic ramp is difficult to achieve, particularly during LDO inrush. The risk of encountering this issue can be minimized by performing one of the following:

- If the VDD and VDDA pins are connected directly to the same power source, at every possible point A and point B along the VDDA waveform between 2.0 V and 2.55 V, point B must never fall below point A after 15  $\mu$ s, as shown in [Figure 3](#).
- Use a separate power supply for VDDA to reduce noise and isolate it from the effects of LDO inrush. At every possible point A and point B along the VDDA waveform between 2.0 V and 2.55 V, point B must never fall below point A after 15  $\mu$ s, as shown in [Figure 3](#). The separate power supply will make it easier to avoid this condition.
